VISIT OF THE SUBSTATION IN ARNHEM 4.12.15

Report of the visit of the substation in Arnhem.

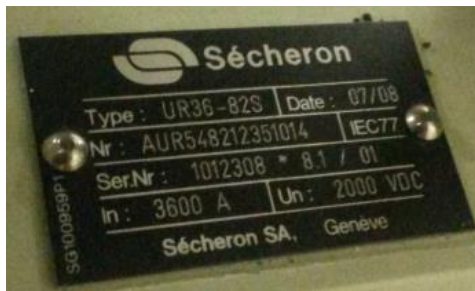
S/N of breaker:

Problem summary: magnetic closing device doesn't come back after tripping (manual or overcurrent).

First we measured the current into the coil with the scope meter with a current probe 10mV/A = the current was at the maximum (4.4 A).

This was due to a bad adjustment of the serial resistor (7.2 instead of 9.4 Ohms).

Then we checked the air gap in the coil and found out that it was set to an electrical holding type (that's why we have to turn back the cover for approximately $\frac{3}{4}$ turn).

Final test: First with external power supply to check the minimum opening current (see table 1.9 A). It was ok.

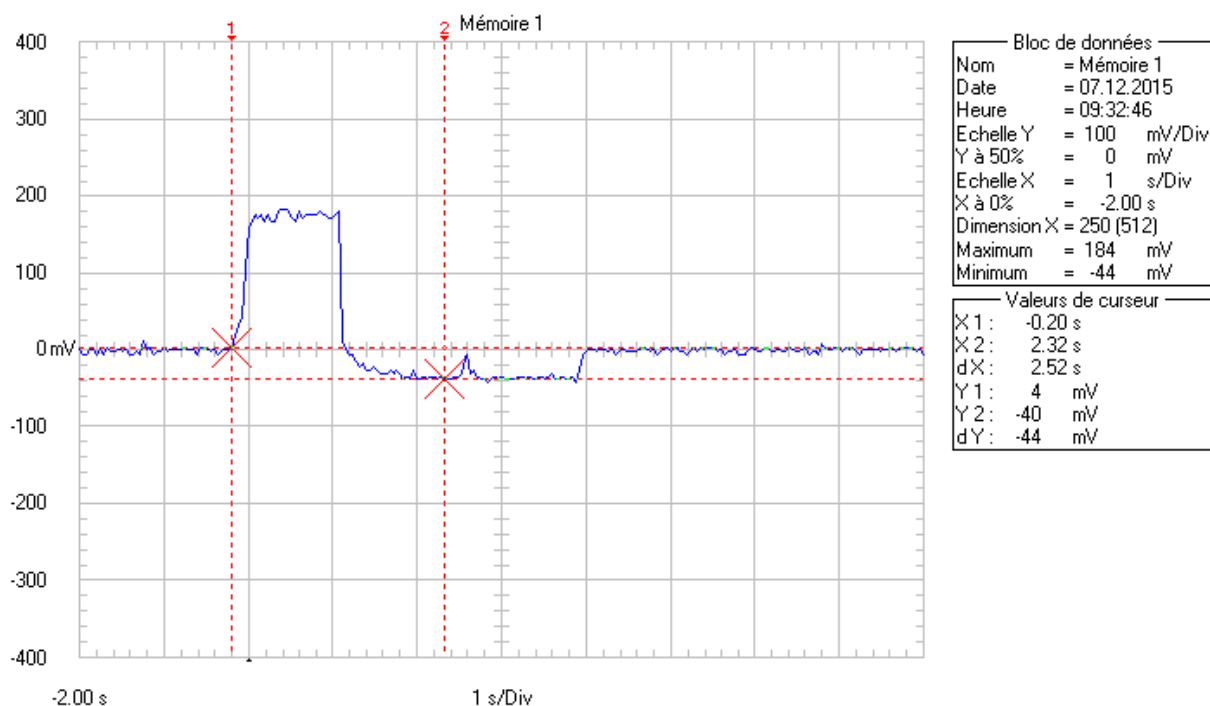
B.3.1 Typical values for the closing coils

See table here bellow for 48 V coil.

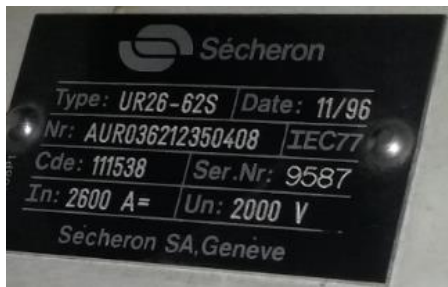
S/N of breaker:

Analysis of a second trolley with an intermittent failure.

First we checked the current and the resistor value: It was ok.

Then we checked the gap. It was ok (8.5mm)

Then we disassembled the closing device, to clean up the touching surface of the moving core from old dry grease. Reassembled the closing device and cleaned up also the fork from old grease and put new grease instead.

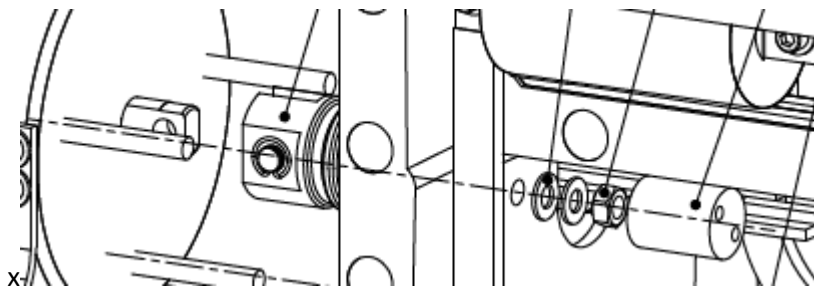
Installation of the new isolation caps on closing devices to decrease the risk of the flash over to the ground.

Action: 6 new washers (9AVA330-12 WASHER ELA TYP SK 8.2/16.2x1.4-SS A4) have to be installed on the oldest breaker, because the diameter of existing ones is too big.

3 caps HSBR430706P0001 SOCKET B 17.2/25x33 M8 PROTECTION-PA 66 SA
